## **Fortuna Union High School District**

### **REQUEST FOR QUALIFICATIONS REQUEST FOR PROPOSALS**

Proposition 39  
HVAC, Fenestration, and Appliance Efficiency Projects

# ASHRAE Level 2 Energy Audit Report

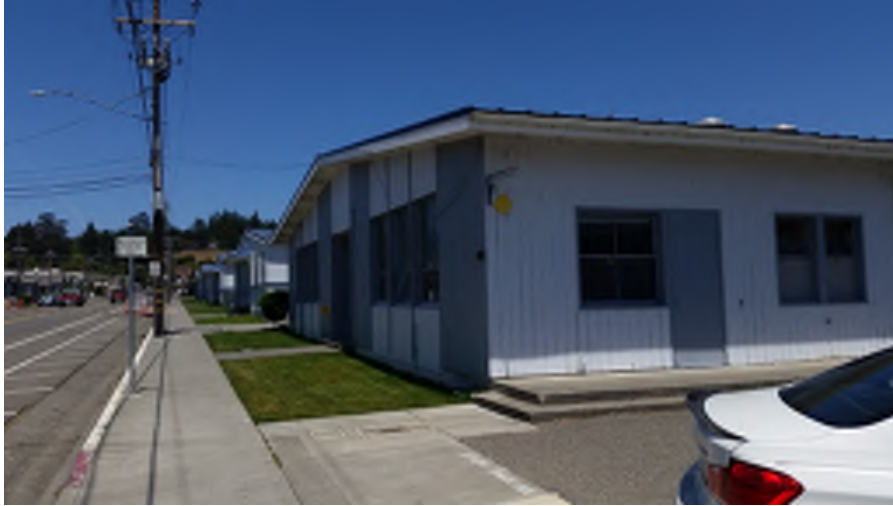
Figure 6. Fortuna Union High School Administration Building (Building A)

The Fortuna Union High School Administration building, originally constructed in 1964, is a single story, wood frame structure covering approximately 6,272 square feet of conditioned floor area on an above grade slab foundation. The building houses primarily offices and meeting spaces in support of the high school's administration.

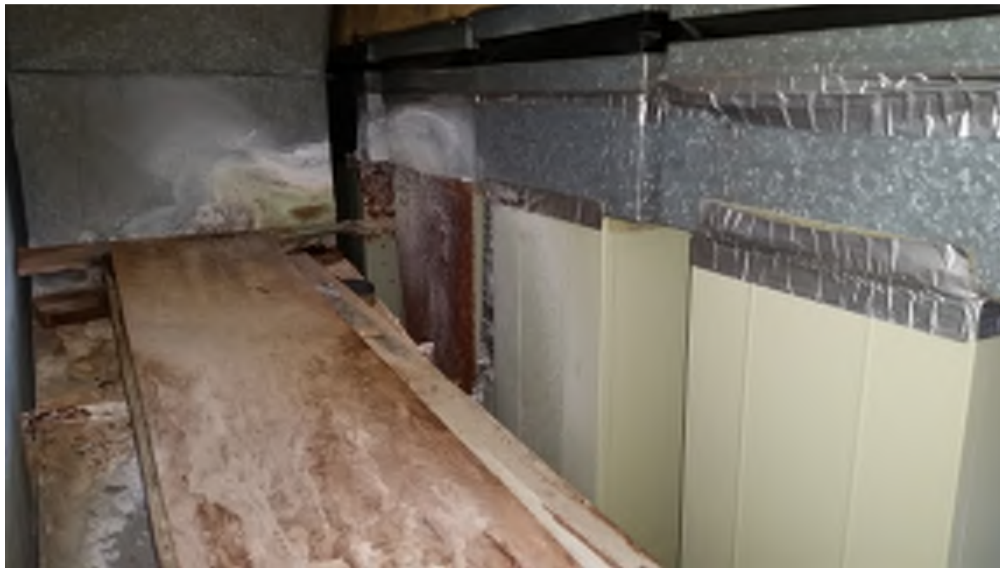
**Figure 7. Shared return plenum behind Building A furnaces**

The five systems also share a single return air plenum, which was observed to be in very poor condition with a number of defects. Since the return plenum is generally under negative pressure relative to the atmosphere, any air or other gases in the mechanical room will be entrained into the return plenum and subsequently delivered to all occupied zones within the building.

One result of the configuration with the shared return plenum located at the rear of the furnace is that there is no location for an air filter that can be easily accessed for regular servicing. No filters were observed in any of the five furnaces in Building A.

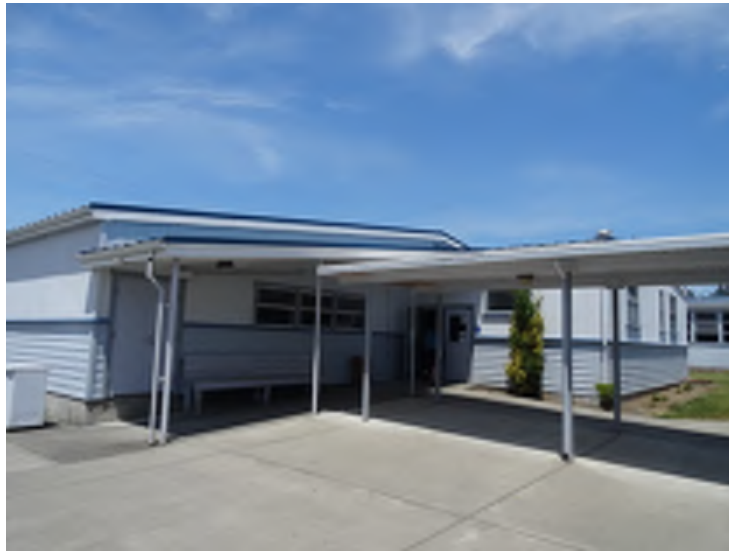
Figure 8: Fortuna Union High School Building B (View From East)

Building B, originally constructed in 1964, is a single story, wood frame structure covering approximately 6,026 square feet of conditioned floor area on an above grade slab foundation. The building houses two computer labs, a classroom, and a foods lab with complete kitchen facilities.

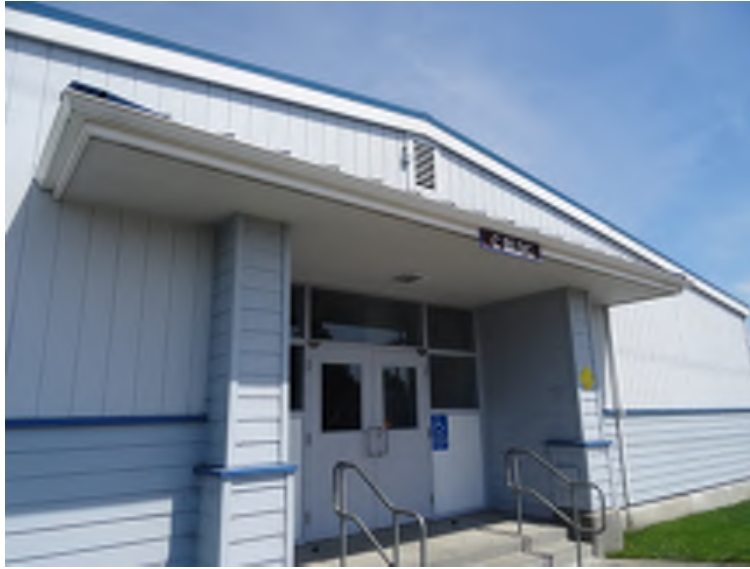
Figure 9: Fortuna Union High School Building C (View from West)

Building C, originally constructed in 1964, is a single story, wood frame structure covering approximately 6,998 square feet of conditioned floor area on an above grade slab foundation. The building houses computer labs and classrooms.

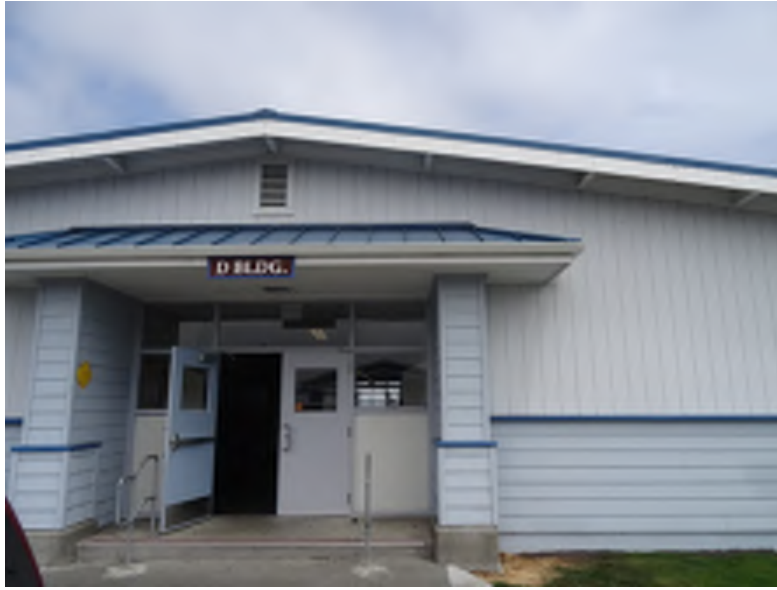
Figure 10. Fortuna Union High School Building D (View from West)

Building D, originally constructed in 1964, is a single story, wood frame structure covering approximately 6,998 square feet of conditioned floor area on an above grade slab foundation. The building houses primarily classrooms.

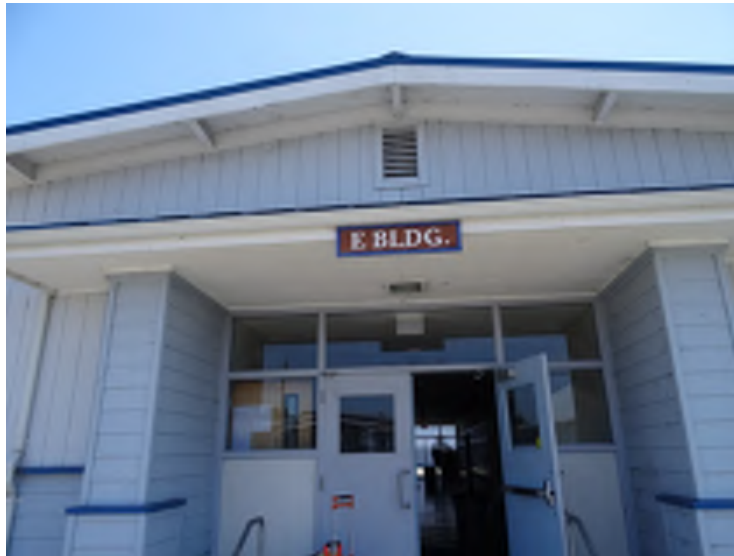
Figure 12: Fortuna Union High School Building E (View from West)

Building E, originally constructed in 1964, is a single story, wood frame structure covering approximately 6,289 square feet of conditioned floor area on an above grade slab foundation. The building houses primarily classrooms.

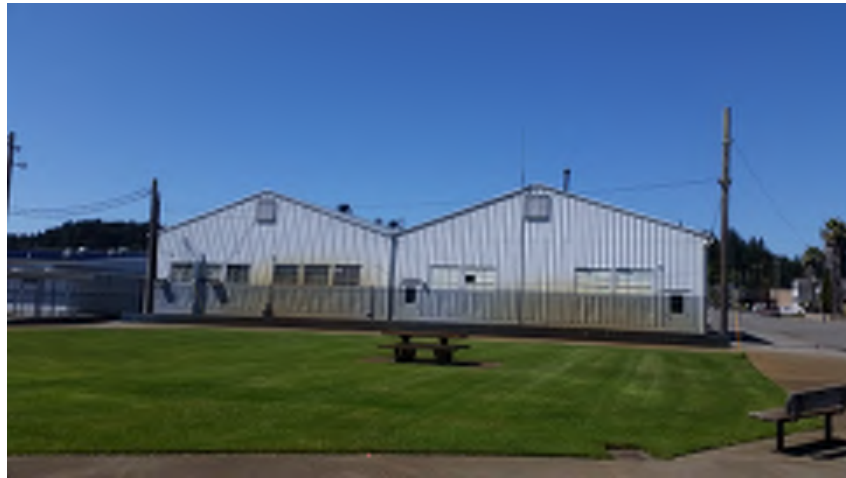
Figure 13. Bus Barn and Auto Shop Building

The Bus Barn and Auto Shop building, is a single story structure covering approximately 6,289 square feet of conditioned floor area on an above grade slab foundation. The building houses two large auto shop instruction and work areas, two classrooms, several offices, and the school bus maintenance garage.

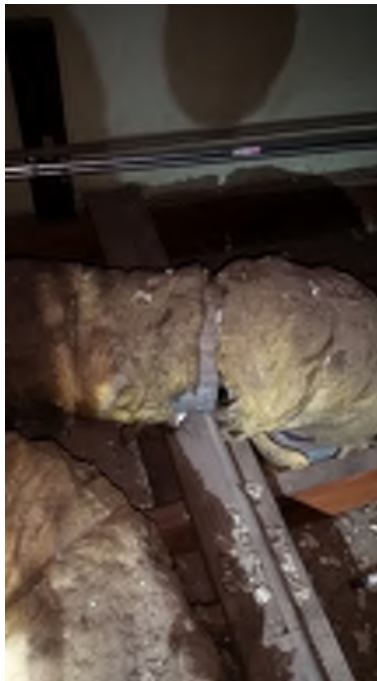
**Figure 14. Severely compromised ducting in Auto Shop Classroom furnace**

The Auto Shop classroom is served by a furnace located in attic space above, which is open to and visible from the auto shop space itself. This 64,000 Btu/hr furnace is quite old and owing to its location where various items have been haphazardly stored over the years, its duct system was observed to be completely disconnected such that any heated air produced by the supply fan is being delivered into the attic space where the unit sits rather than into the classroom heat registers. The furnace combustion efficiency was not tested because the unit is so old and the installation is so compromised that complete replacement of the entire unit is recommended. Additionally, the existing furnace, when functional, was likely substantially oversized for the small zone it serves.

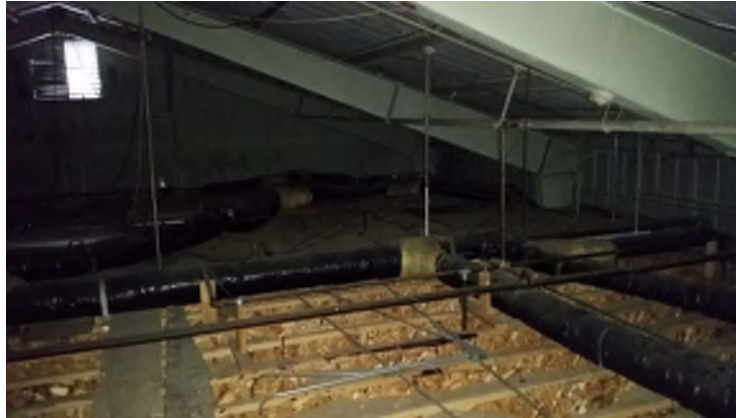
**Figure 15. Long duct runs to a total of 10 registers from a single small HVAC system**

The southwest corner of the Auto Shop building housing offices is heated by a single 59,000 Btu/hr furnace that is approximately 20 years old. This unit is substantially undersized for the approximately 2,500 square feet of poorly insulated space it serves. A total of 10 individual registers were observed at the end of long duct runs connected to two main duct trunk lines manifolded to the supply air plenum.

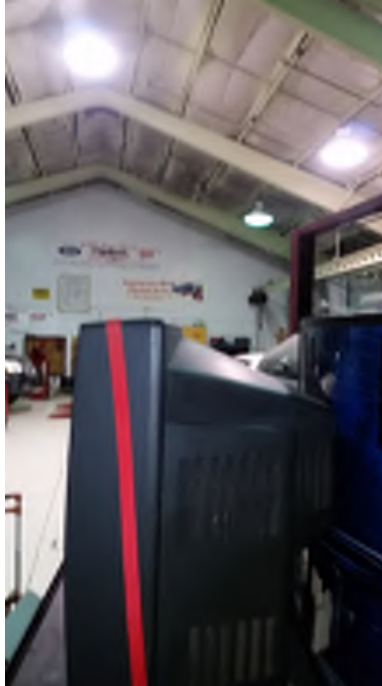
**Figure 16. HID lights in the Auto Shop**

While the rest of the building has standard efficiency T8 fluorescent lighting, the Auto Shop is lit with nine high intensity discharge (HID) metal halide (MH) lamps. These lamps were not accessible to determine the exact wattage but they are assumed to be a minimum of 400 watts each. . The lights in each shop are wired to operate from a single switch so that no part of either shop can be lit without energizing all 9 of its lights. Depending on the actual size of the lamps, the lighting power density for the Auto Shop could be anywhere in the range of 1.6 up to 4.0 watts per square foot, compared to the current Title 24 allowable standard of 1.0 watts per square foot. Since HID lamps require significant cool down time before they can be restruck after shut down, occupancy sensors cannot be utilized with them, and it is typical for these types of lamps to be left on all day once they are turned on in the morning.

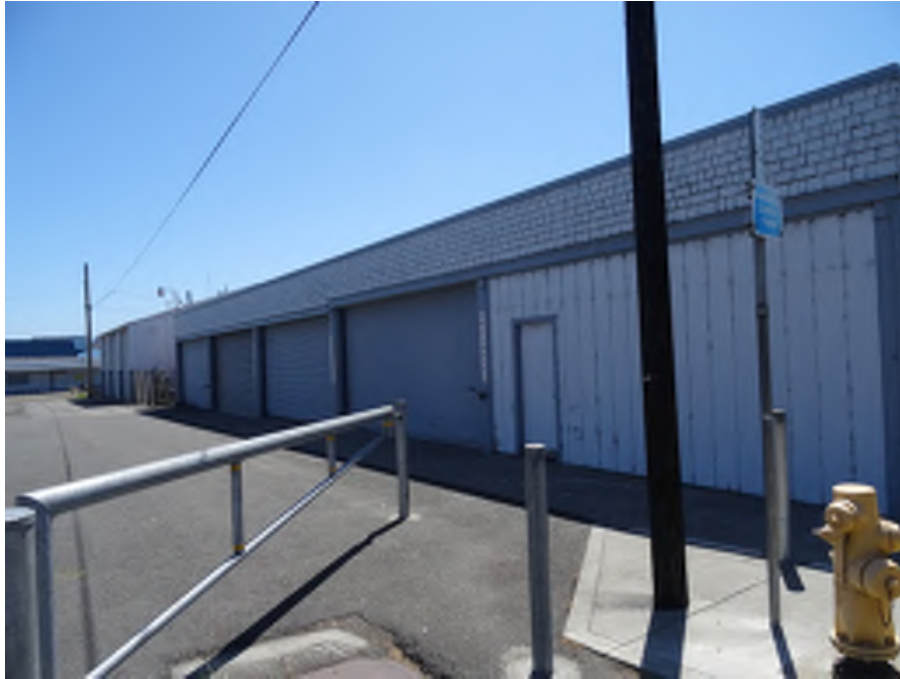
Figure 17. Bus Shed

The Bus Shed, originally constructed in 1964, is a single story, wood frame structure covering approximately 3,750 square feet of unconditioned floor area on an above grade slab foundation. The building is used exclusively for parking.

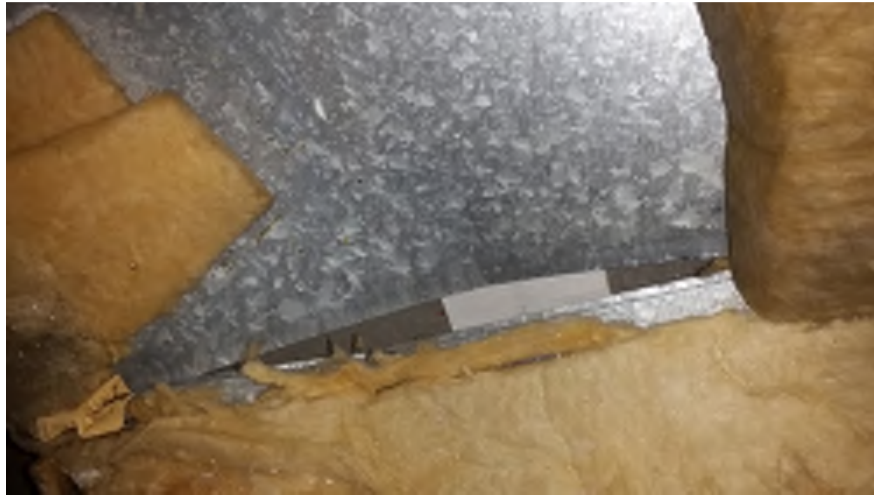
**Figure 18. Collapsed duct with major leak above classroom F5**

While most of the supply ductwork is insulated, much of the insulation was observed to be in very poor condition, with large expanses of metal ducting completely exposed. Several leaks in the ducts were also observed, the most severe of which is a completely collapsed duct near the register closest to the attic access hatch outside Room F5. When ducts leak supply air into unconditioned spaces, not only is the amount of heated supply air that leaks completely wasted, but the situation is made worse by the fact that 100% of the air drawn out of the conditioned zone back into the furnace through the return duct must be made up by infiltration of outside air into the space through cracks around doors and windows and from any connected attic or crawlspace.

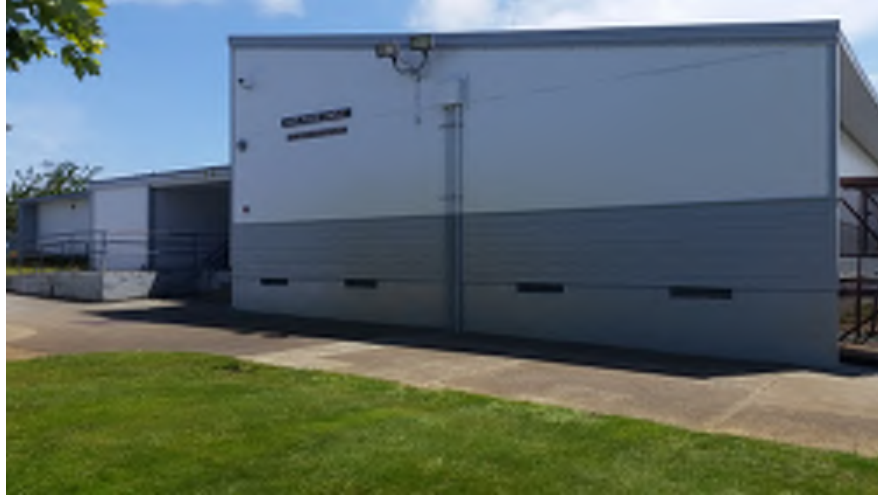
Figure 19. Fortuna Union High School Wayne Rogers Complex/Industrial Technology (View from Southwest)

The Wayne Rogers Complex is a single story structure covering approximately 8,788 square feet of conditioned floor area. The building houses two large shop instruction and work areas in addition to two small offices and several storage areas. The Wood Shop sits on a perimeter foundation over a crawlspace, whereas the Metal Shop section sits on an above grade concrete slab foundation.

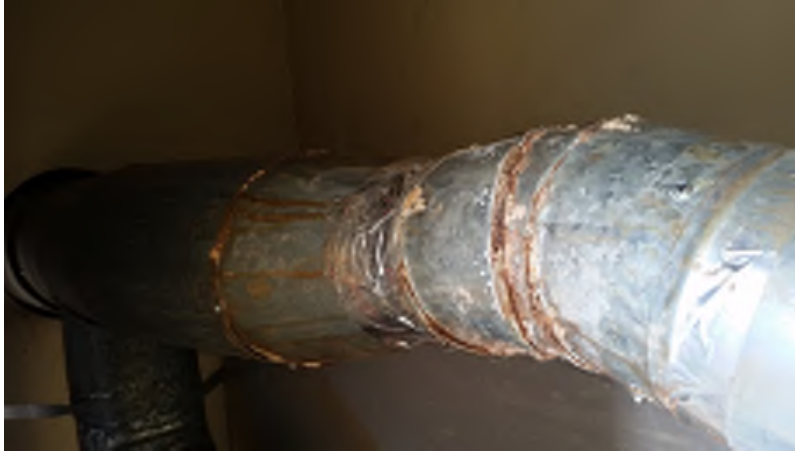
**Figure 21. Corrosion of common shared flue in Wood Shop furnace closet**

The Wood Shop furnaces share a common exhaust flue stack which exhibits signs of significant corrosion attributable to the condensation of corrosive fluids common in this configuration.

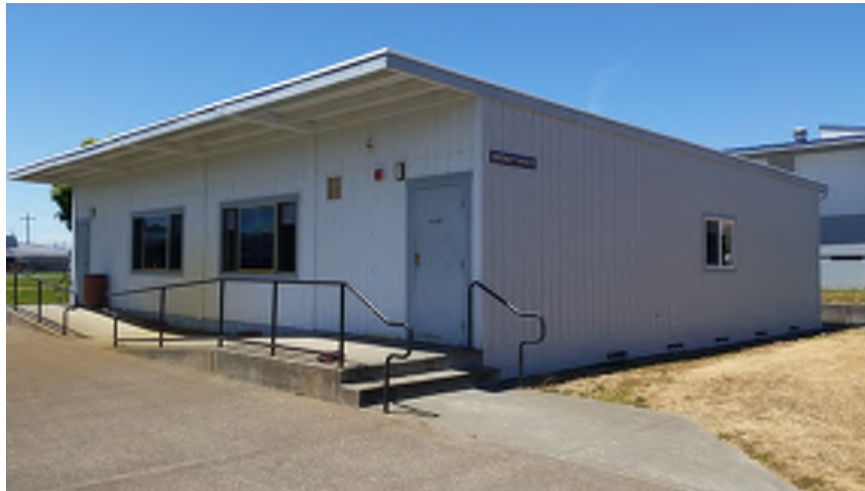
Figure 22. Fortuna Union High School District Office (View from Southeast)

The District Office, originally constructed in 2001, is a single story, wood frame, modular manufactured structure covering approximately 1,920 square feet of conditioned floor area. This building is constructed on a pier and post foundation and houses primarily office space.

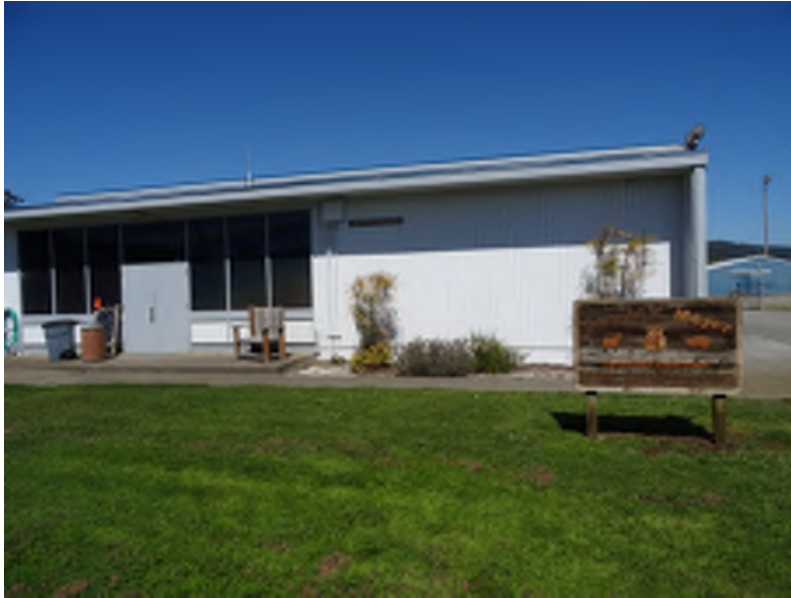
Figure 23. Fortuna Union High School Agriculture Building (View from West)

The Agriculture Building, originally constructed in 1981, is a single story structure covering approximately 9,830 square feet of conditioned floor area. The building houses a large shop instruction and work area in addition to two classrooms, an office and storage areas. The Ag Building sits on a raised slab foundation.

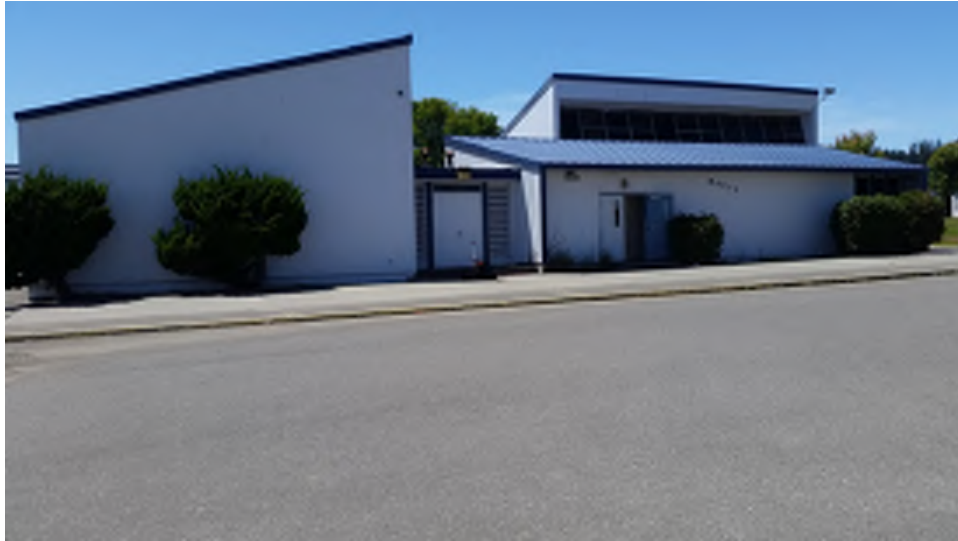
Figure 25. Fortuna Union High School Music Building (View from East)

The Music Building, originally constructed in 1981, is a single story, wood frame structure covering approximately 4,960 square feet of conditioned floor area on an above grade slab foundation. The building houses primarily two large rehearsal halls, smaller recording studios, and several small office and storage areas.

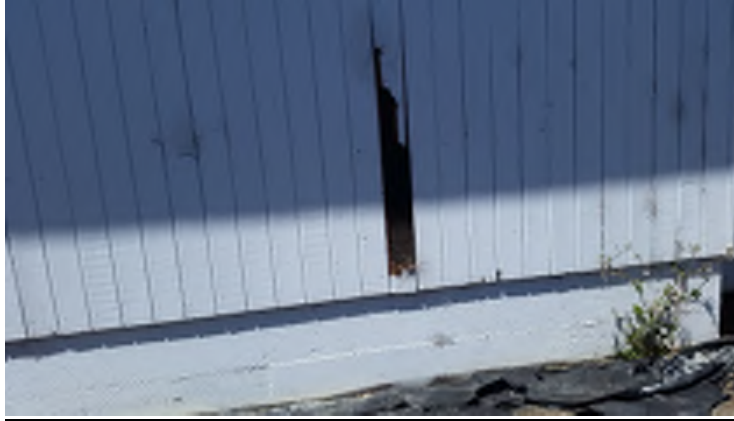
Figure 26. Moisture damage to siding of Music Building

- Roof – The roof of the Music building is a standing seam metal roof that appeared to be in good condition.
- Roof drainage – The Music building roof has narrow eaves with no gutters or drainage system, which likely contributes greatly to the generally very poor condition of the exterior siding.

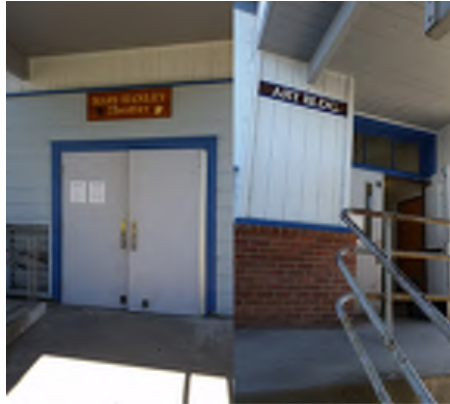
Figure 27. Photos of Fortuna Union High School Art and Theatre Sections of Arts/Theatre Building (View from North)

The Arts/Theater Building, originally constructed in 1952, is a single story, wood frame structure covering approximately 7,869 square feet of conditioned floor area over a perimeter foundation.

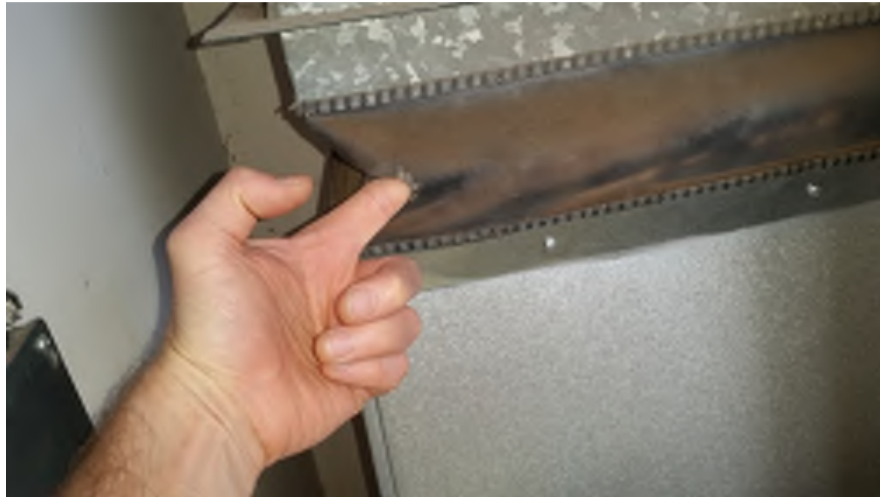
**Figure 28. Leak in supply plenum of Ceramics Lab furnace**

All three of these systems appear to utilize older duct systems from prior furnaces, located in overhead chases. It is uncertain whether these ducts are insulated but it appears they are not. Both units serving the Ceramics and Photo labs have fabric expansion joints at the top of their supply plenums that are severely compromised and leaking heated supply air into unconditioned space. Both units utilize return ducting in the crawlspace, which was not easily accessible during this audit. The filters in all three of these systems were observed to be in very poor condition. While the mechanical closets within which these furnaces reside have provision for adequate combustion air through exterior wall penetrations, these systems do not appear to provide any outside air ventilation to the conditioned space.

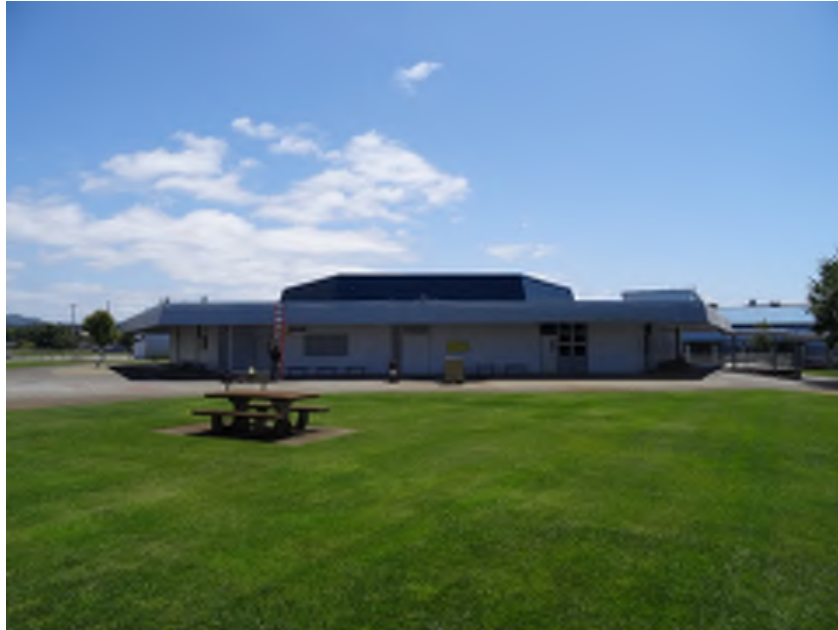
Figure 30. Library / Communicative Arts Building

The Library building, originally constructed in 1978, is a single story, wood frame structure covering approximately 14,614 square feet of conditioned floor area over a slab on grade foundation. The hexagonal building houses a library and computer lab in its center, with classrooms, storage areas, and a space housing the campus information technology (IT) center around its perimeter.
